## SUPPLEMENTARY MATERIAL

### Experimental investigation of local scour under two oblong piers of bridge crossing a sharp bend river

University of Technology, Civil Engineering Department, Al-sina'a St, P.O Box 19006, Baghdad, Iraq

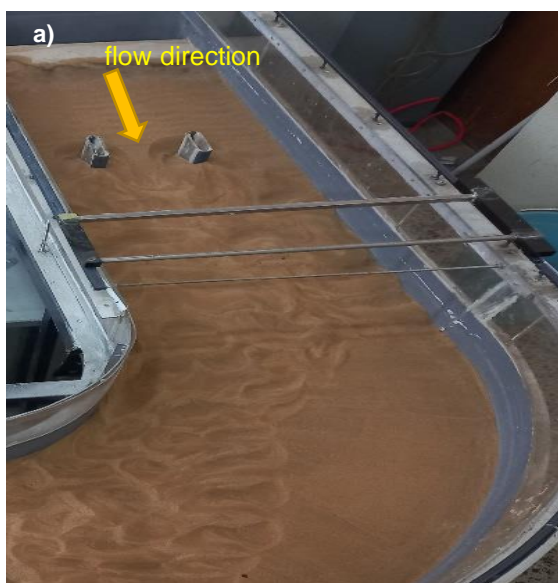
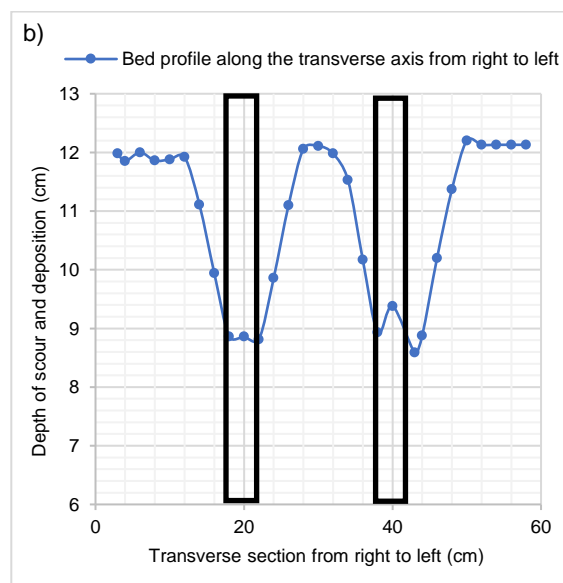
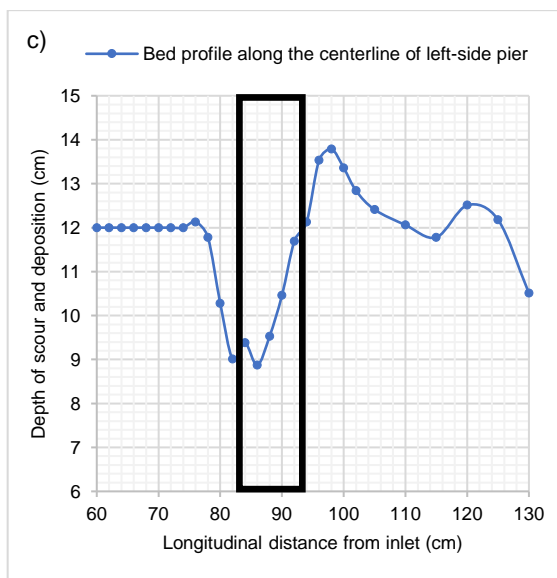
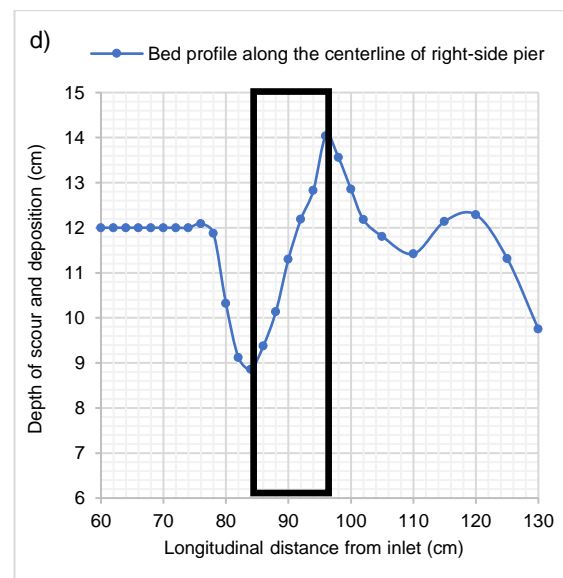
**Fig. S1.** Bridge located at mid-section of upstream reach: a) bed topography around piers, b) transverse profile of bed from right to left at mid-section, c) longitudinal profile of bed along the left-side pier at mid-section, d) longitudinal profile of bed along the right-side pier at mid-section; source: own study

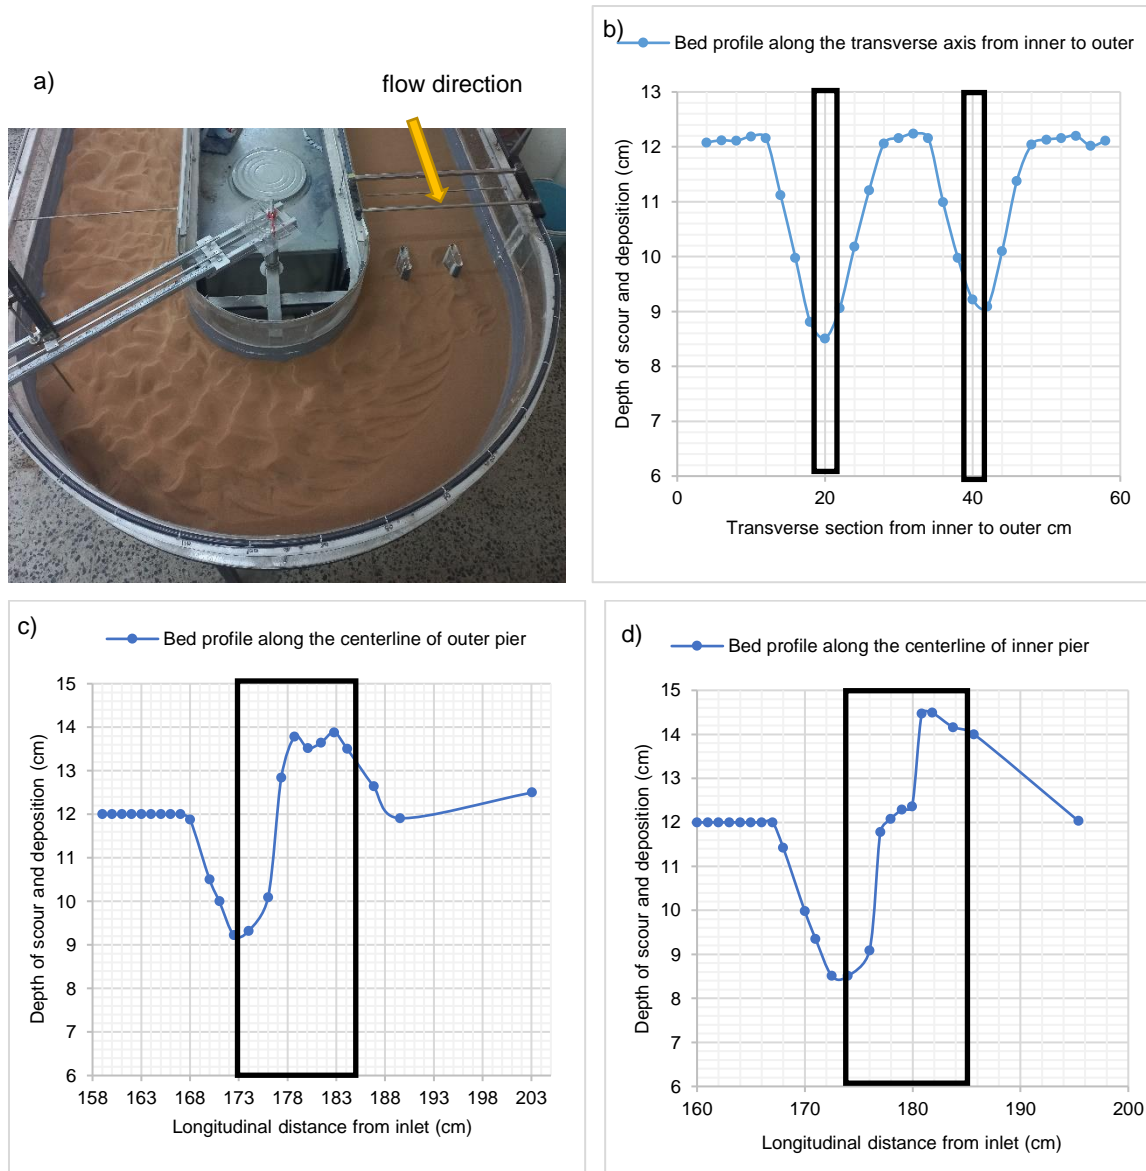
**Fig. 2S.** bridge located at a  $0^\circ$  angle: a) bed topography around piers, b) transverse profile of bed from the inner to outer bank at  $0^\circ$  angle, c) Longitudinal profile of bed along the outer bank at a  $0^\circ$  angle, d) Longitudinal profile of bed along the inner bank at a  $0^\circ$  angle

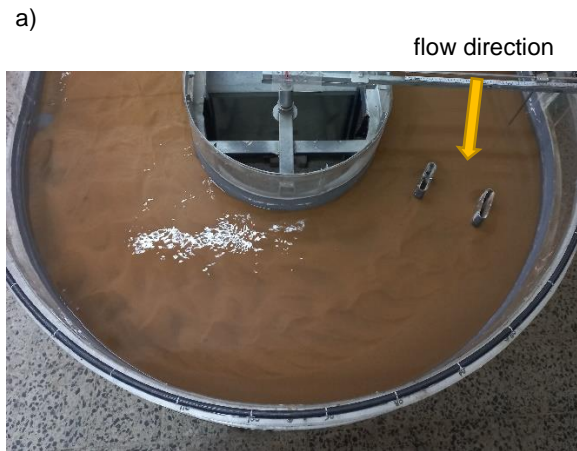
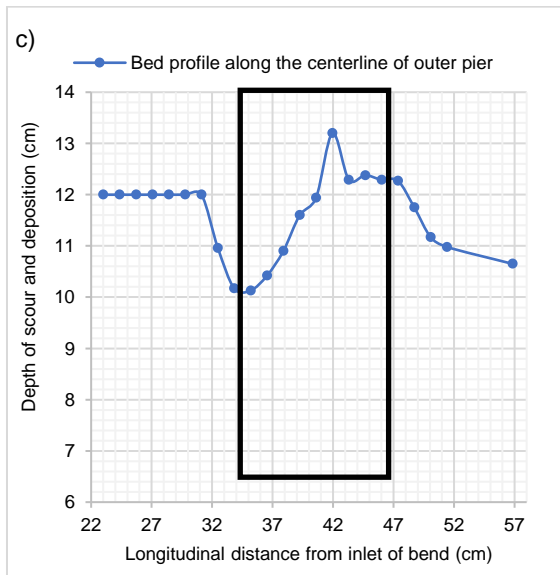
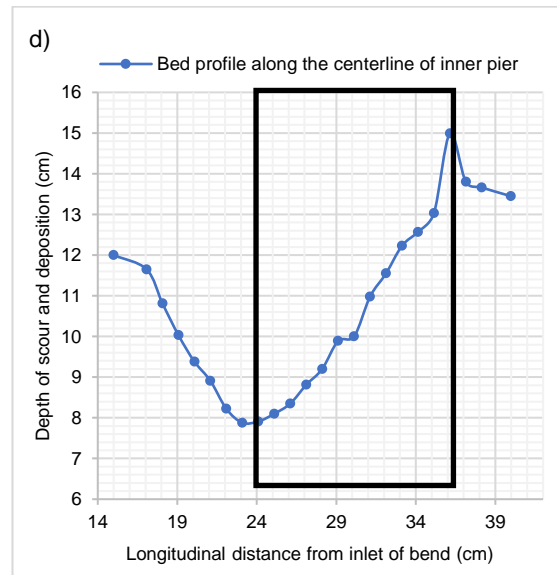
**Fig. S3.** Bridge located at a  $30^\circ$  angle: a) bed topography around piers, b) transverse profile of bed from the inner to outer bank at  $30^\circ$  angle, c) longitudinal profile of bed along the outer bank at a  $30^\circ$  angle, d) longitudinal profile of bed along the inner bank at a  $30^\circ$  angle; source: own study

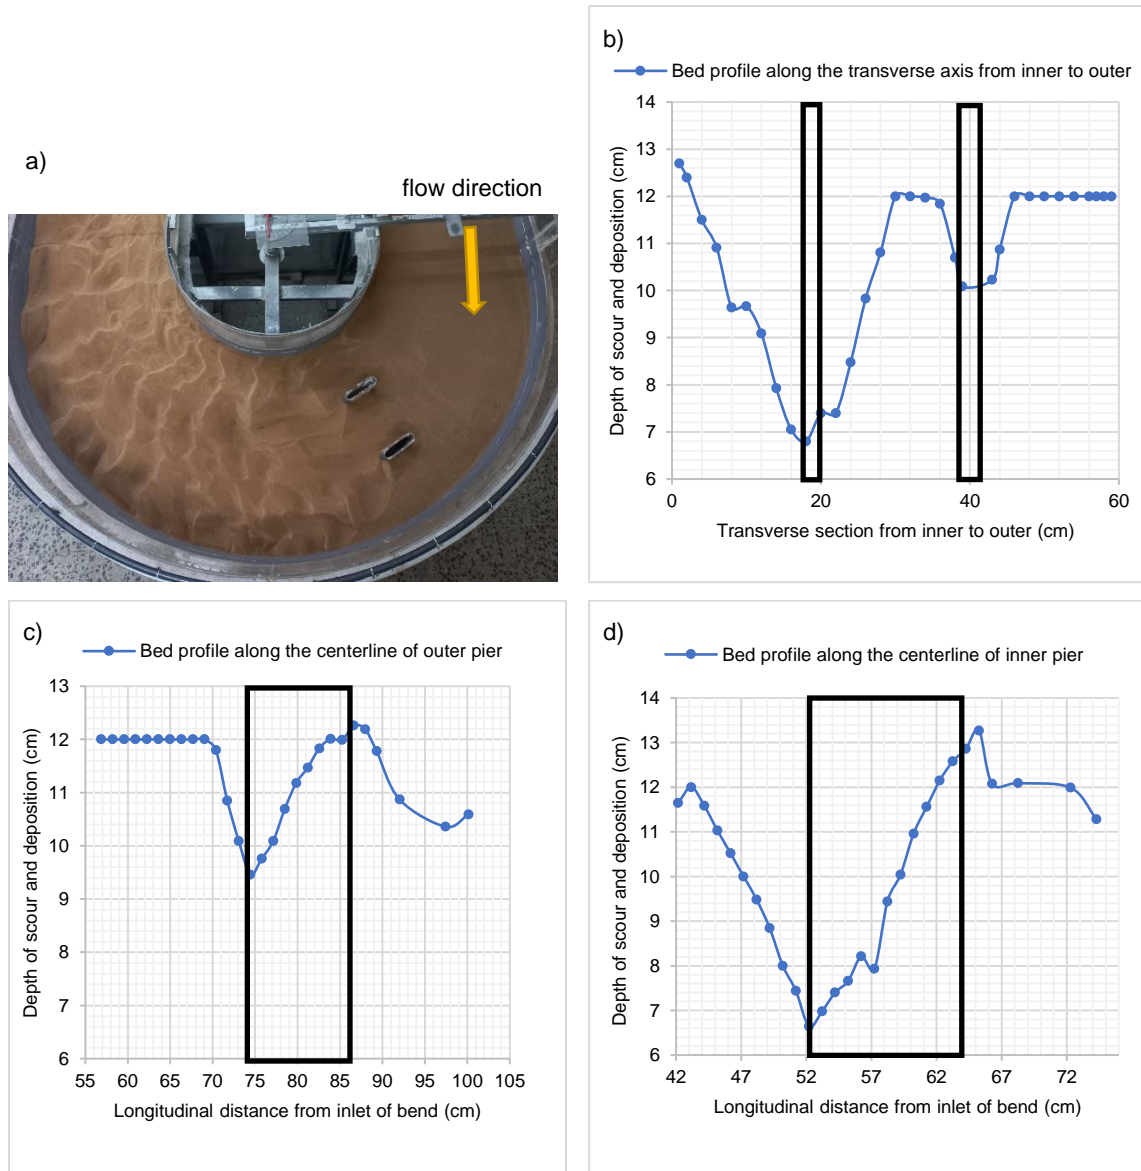
**Fig. S4.** Bridge located at a  $60^\circ$  angle: a) bed topography around piers, b) transverse profile of bed from the inner to outer bank at  $60^\circ$  angle, c) longitudinal profile of bed along the outer bank at a  $60^\circ$  angle, d) longitudinal profile of bed along the inner bank at a  $60^\circ$  angle; source: own study

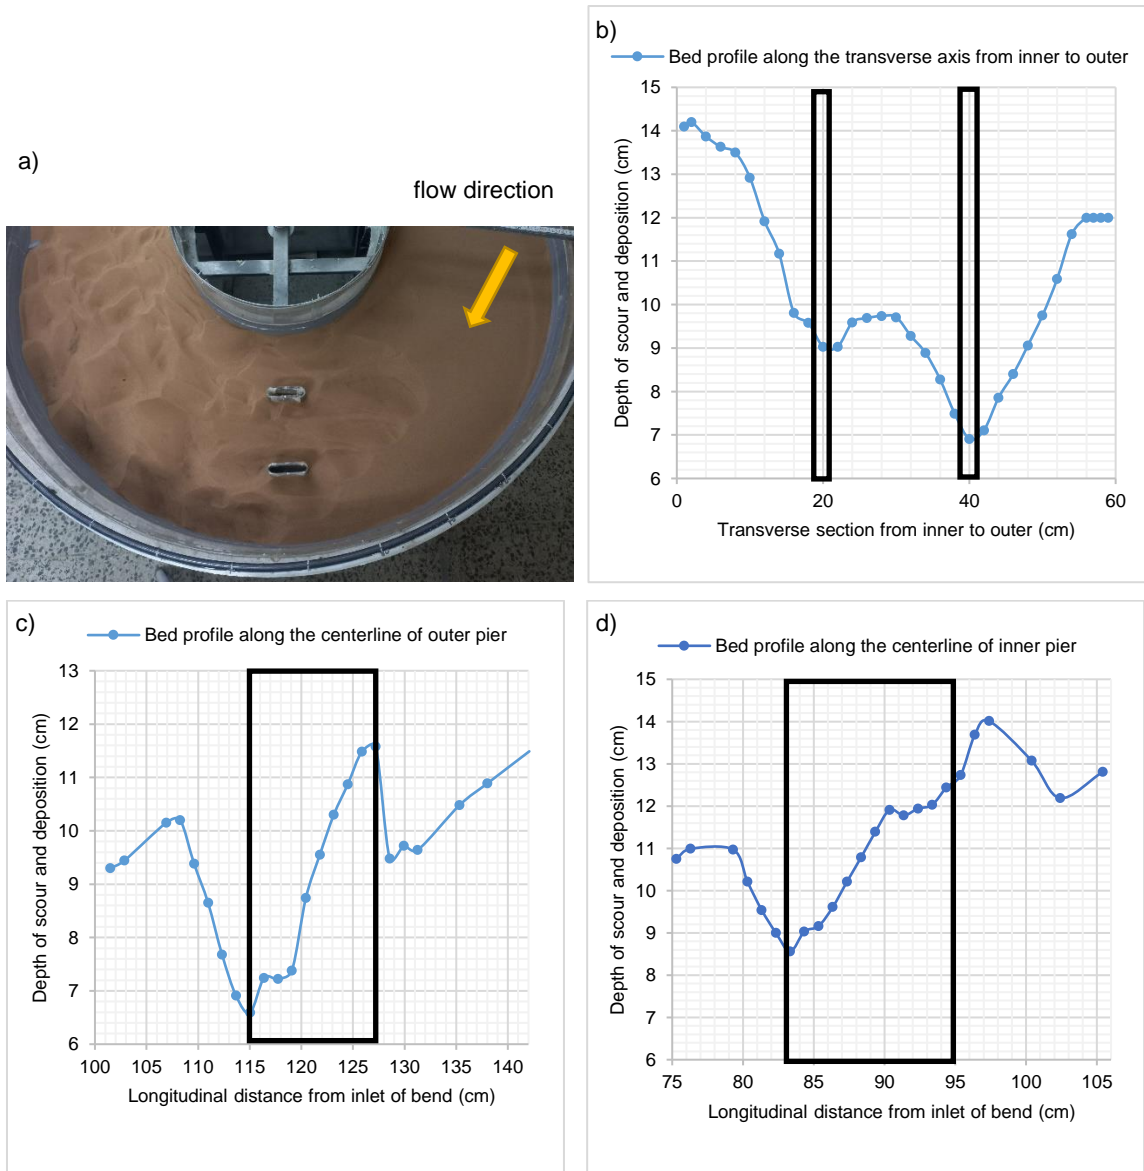
**Fig. S5.** Bridge located at a  $90^\circ$  angle: a) bed topography around piers, b) transverse profile of bed from the inner to outer bank at  $90^\circ$  angle, c) longitudinal profile of bed along the outer bank at a  $90^\circ$  angle, d) longitudinal profile of bed along the inner bank at a  $90^\circ$  angle; source: own study

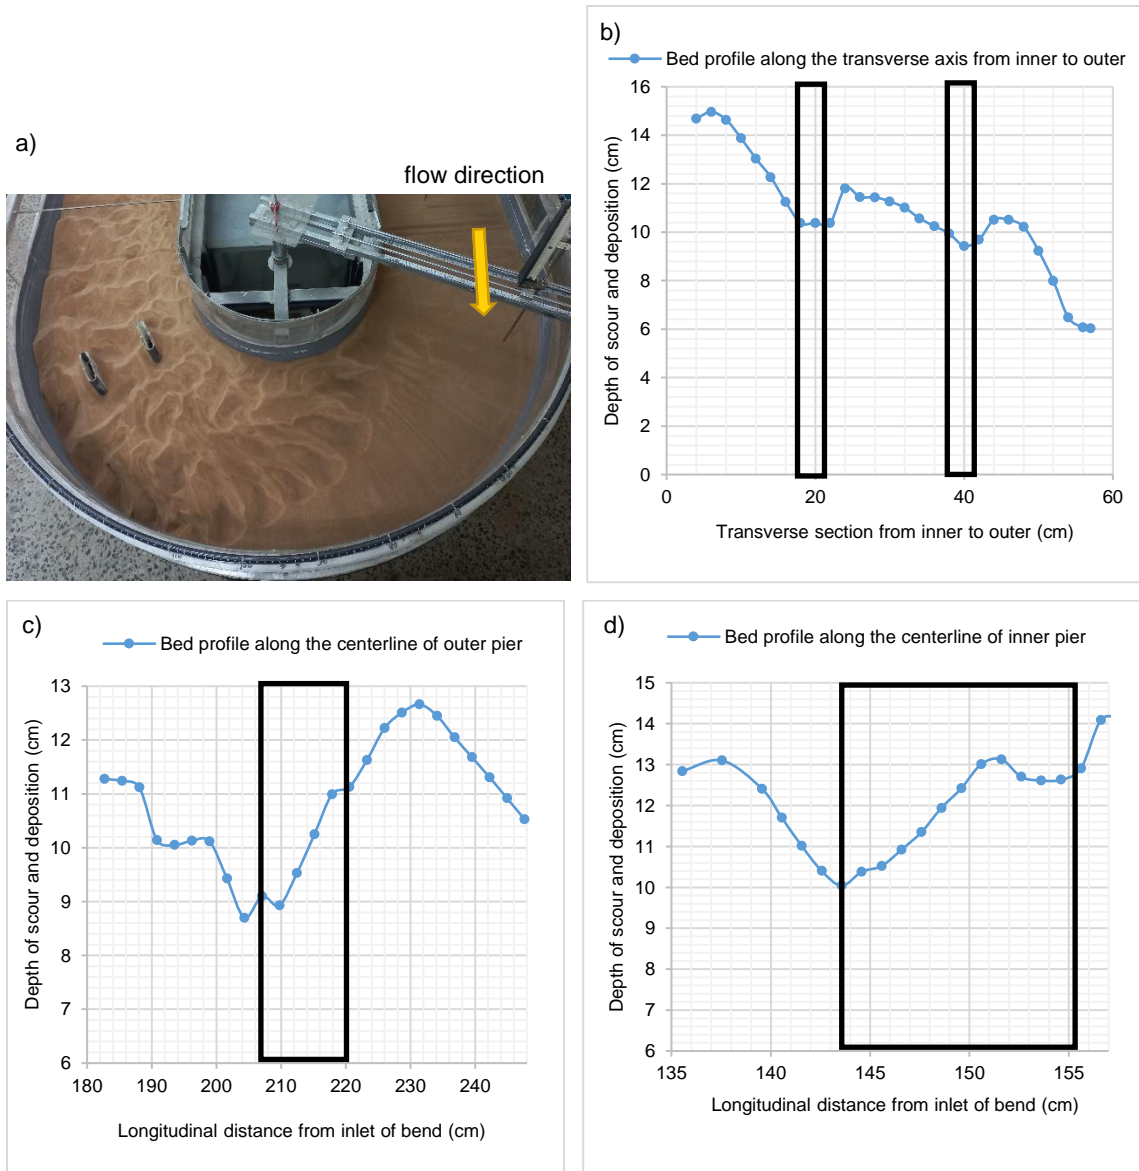
**Fig. S7.** Bridge located at a  $150^\circ$  angle: a) bed topography around piers, b) transverse profile of bed from the inner to outer bank at  $150^\circ$  angle, c) longitudinal profile of bed along the outer bank at a  $150^\circ$  angle, d) longitudinal profile of bed along the inner bank at a  $150^\circ$  angle; source: own study

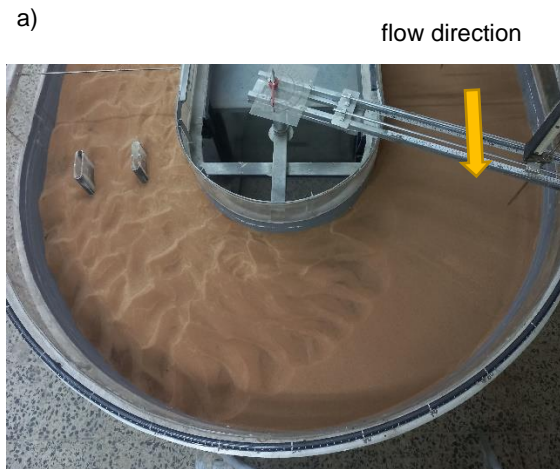
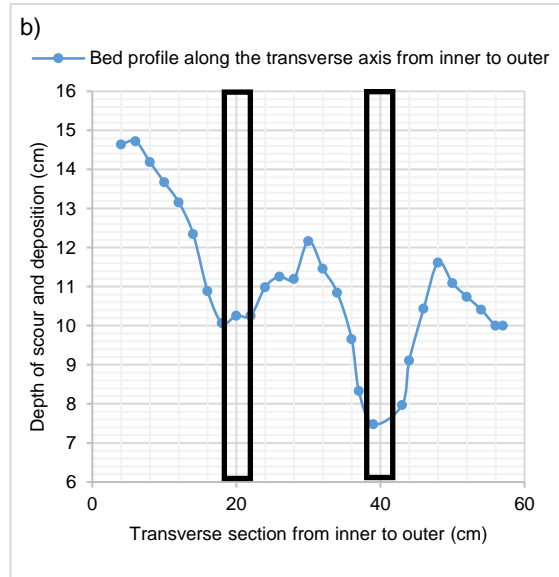
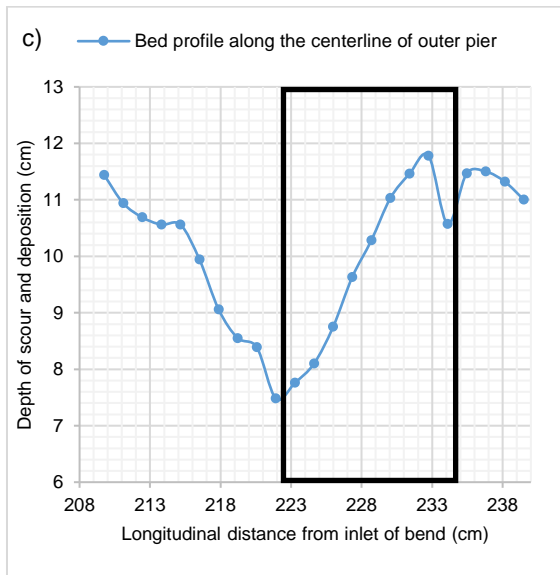
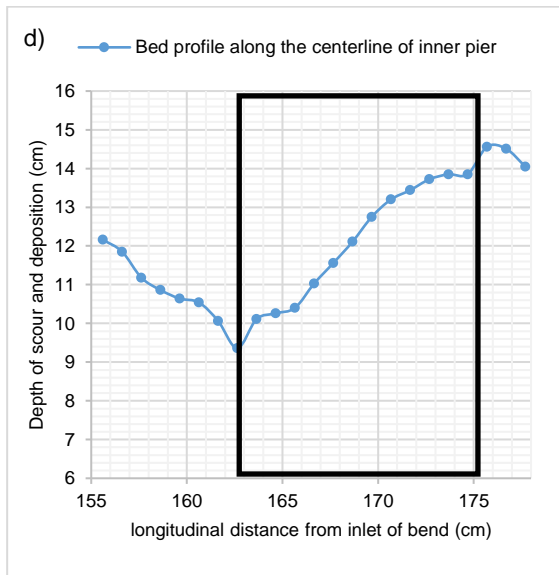
**Fig. S8.** Bridge located at a  $170^\circ$  angle: a) bed topography around piers, b) transverse profile of bed from the inner to outer bank at  $170^\circ$  angle, c) longitudinal profile of bed along the outer bank at a  $170^\circ$  angle, d) longitudinal profile of bed along the inner bank at a  $170^\circ$  angle; source: own study

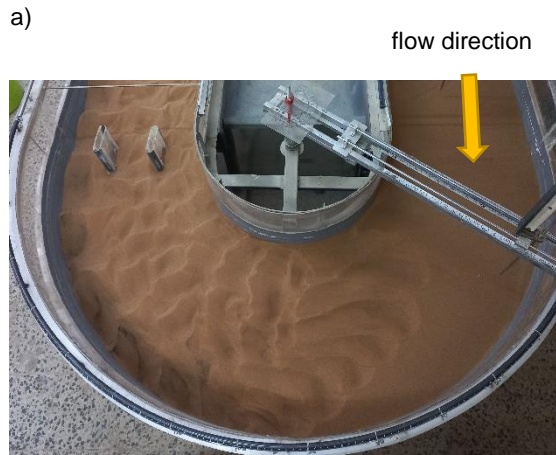
**Fig. S9.** Bridge located at a  $180^\circ$  angle: a) bed topography around piers, b) transverse profile of bed from the inner to outer bank at  $180^\circ$  angle, c) longitudinal profile of bed along the outer bank at a  $180^\circ$  angle, d) longitudinal profile of bed along the inner bank at a  $180^\circ$  angle; source: own study
