# A proposed quantitative method for assessing the impact of river regulation on its hydromorphological status

**Abstract:** Changes in river channel morphological parameters are influenced by anthropogenic factors, such as climatic changes, river catchment management changes, and hydrotechnical development of rivers. To assess the intensity of individual pressures and the resulting changes in abiotic and biotic factors in the riverbed, water quality monitoring is conducted, including the assessment of the hydromorphological status. The assessment can be based on the River Habitat Survey (RHS) which is a synthetic method that includes the evaluation of habitat character and river quality based on their morphological structure.

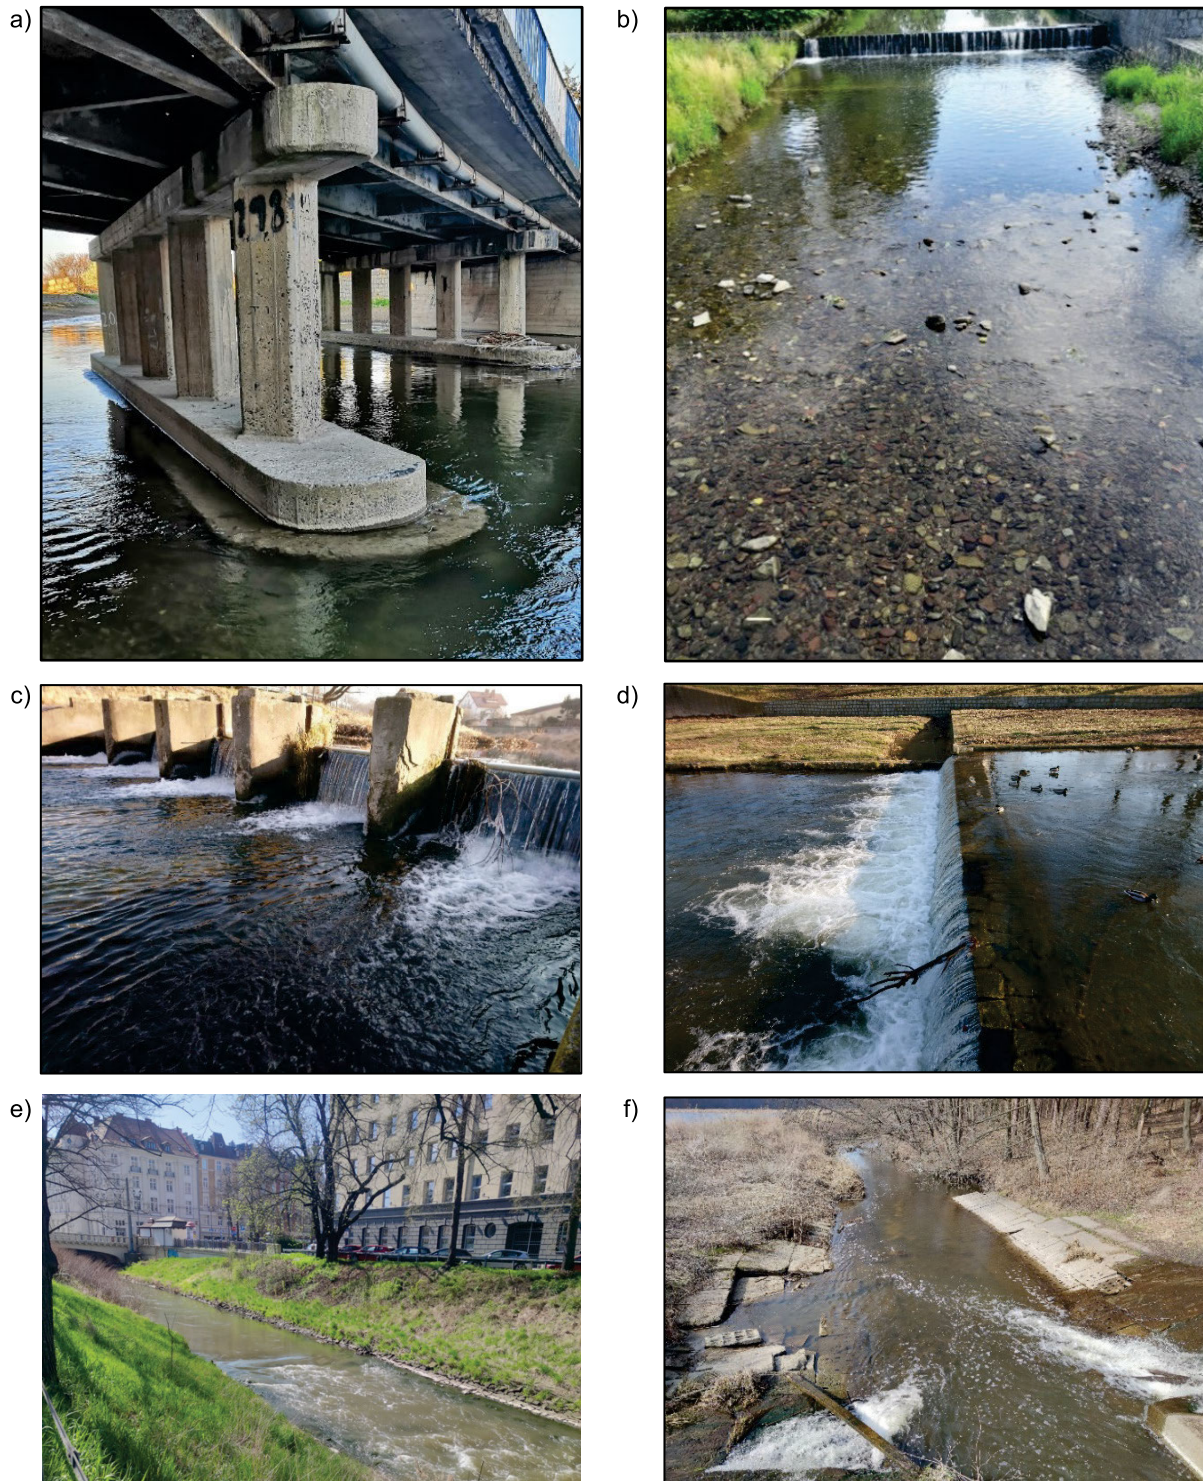
**Photo 1.** River valley morphological elements included in the River Habitat Survey method: a) bridge piers (the Bystrzyca River), b) visible bottom granulation (the Bystrzyca River), c) concrete weir (the Pilawa River), d) hydraulic jump visible downstream the stone weir (the Bystrzyca River), e) transition from smooth to turbulent forms of water movement (the Kłodnica River), f) devastated bed and riparian concrete reinforcement (the Czarna River) (phot.: M. Kiraga)
